FOUNDATION PREPARATION

Project Name: Cobre Panama  
 Area No: 363  
 Area Description: Tailings Dam  
 DWG No: 1824-363-CI-DRG-9144-0  
 ITP No: \_\_\_\_\_

# TMF NORTH DAM SECTOR 1

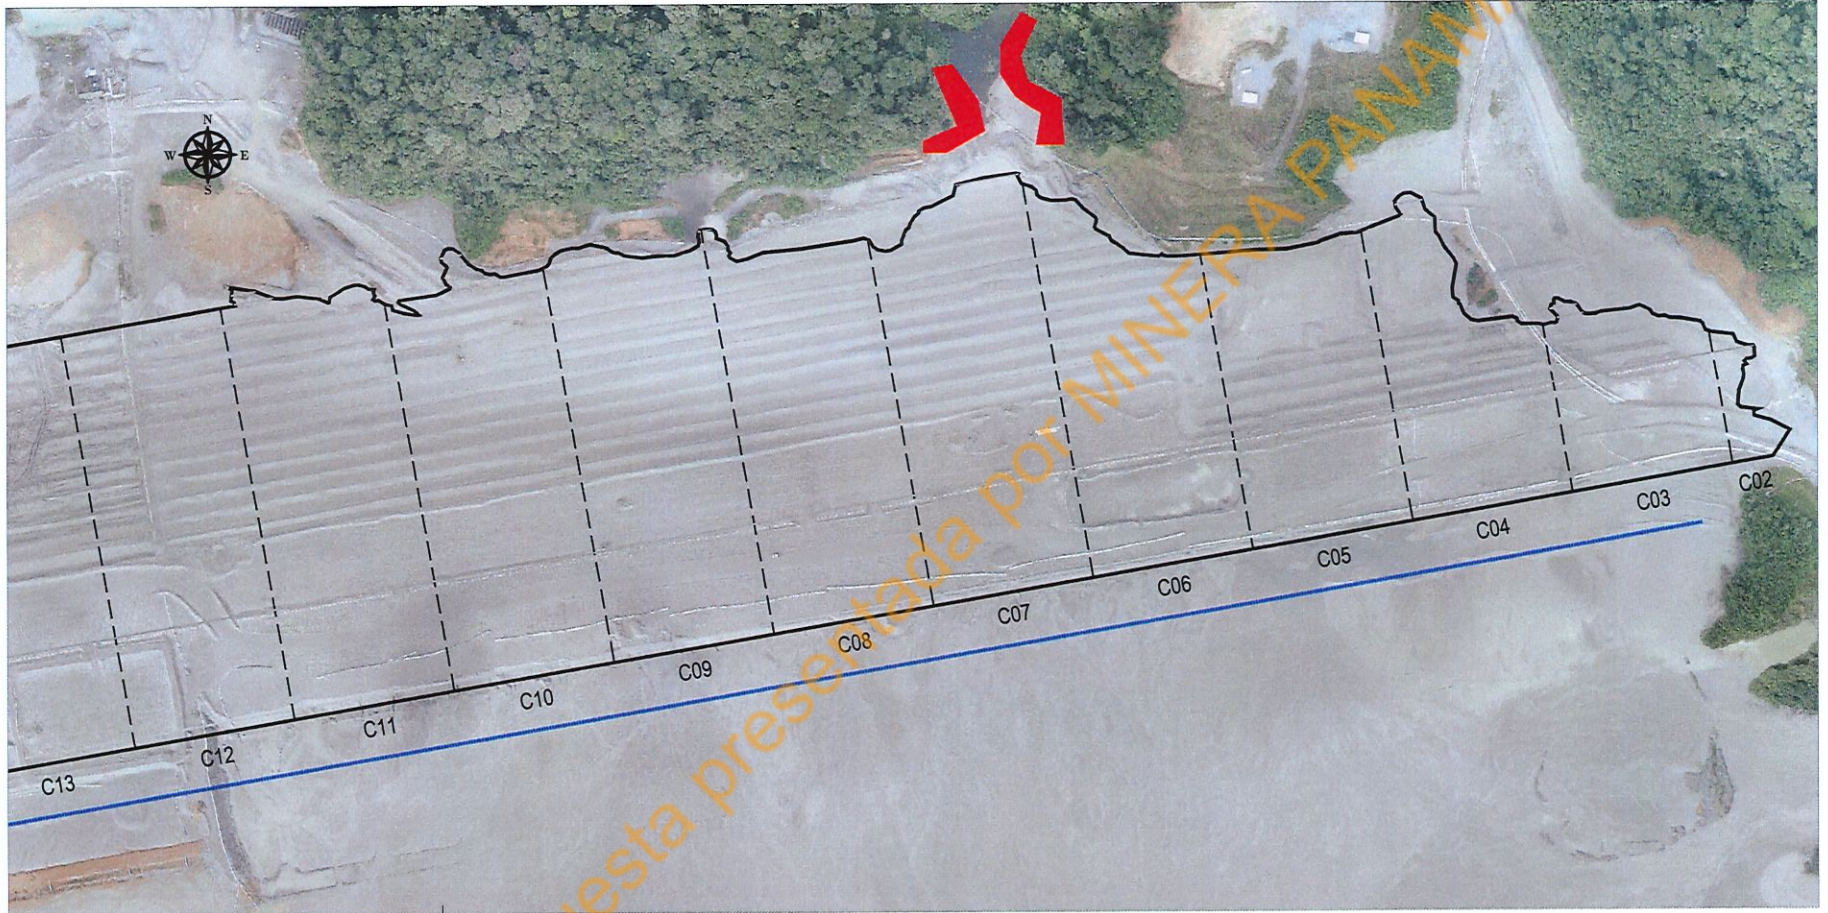
Foundation stands on natural ground consisting on tosca

FOUNDATION
		LOCATION: ND1 Cofferdam	
		AREA: 353.58 m <sup>2</sup>	
		VOLUME: m <sup>3</sup>	
		ELEVATION: 56.53 @ 57.02 m

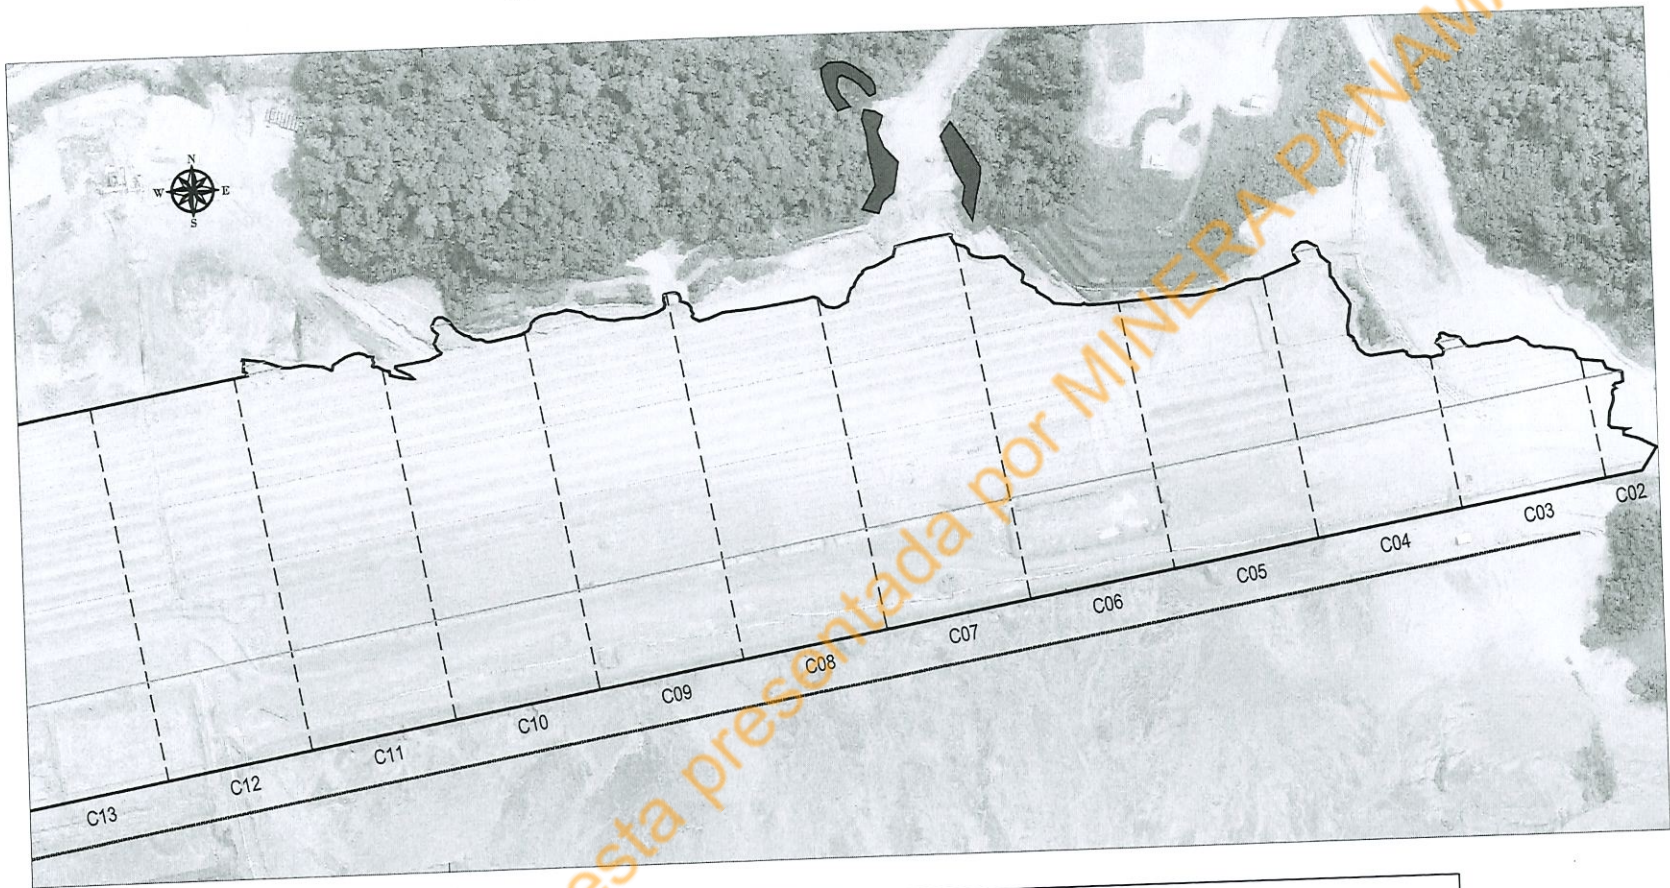
# TMF NORTH DAM SECTOR 1

Foundation consisting of saprolite with coarse rock.

ZONE 1	LOCATION: TMF ND1 COFFERDAM AREA: 465.99M2 VOLUME: ELEVATION: 55.56m to 57.21m
